US Army Corps
of Engineers
Waterways Experiment
Station

Technical Report CERC-95-9
July 1995

Monitoring of the Yaquina Bay Entrance North Jetty at Newport, Oregon; Summary and Results

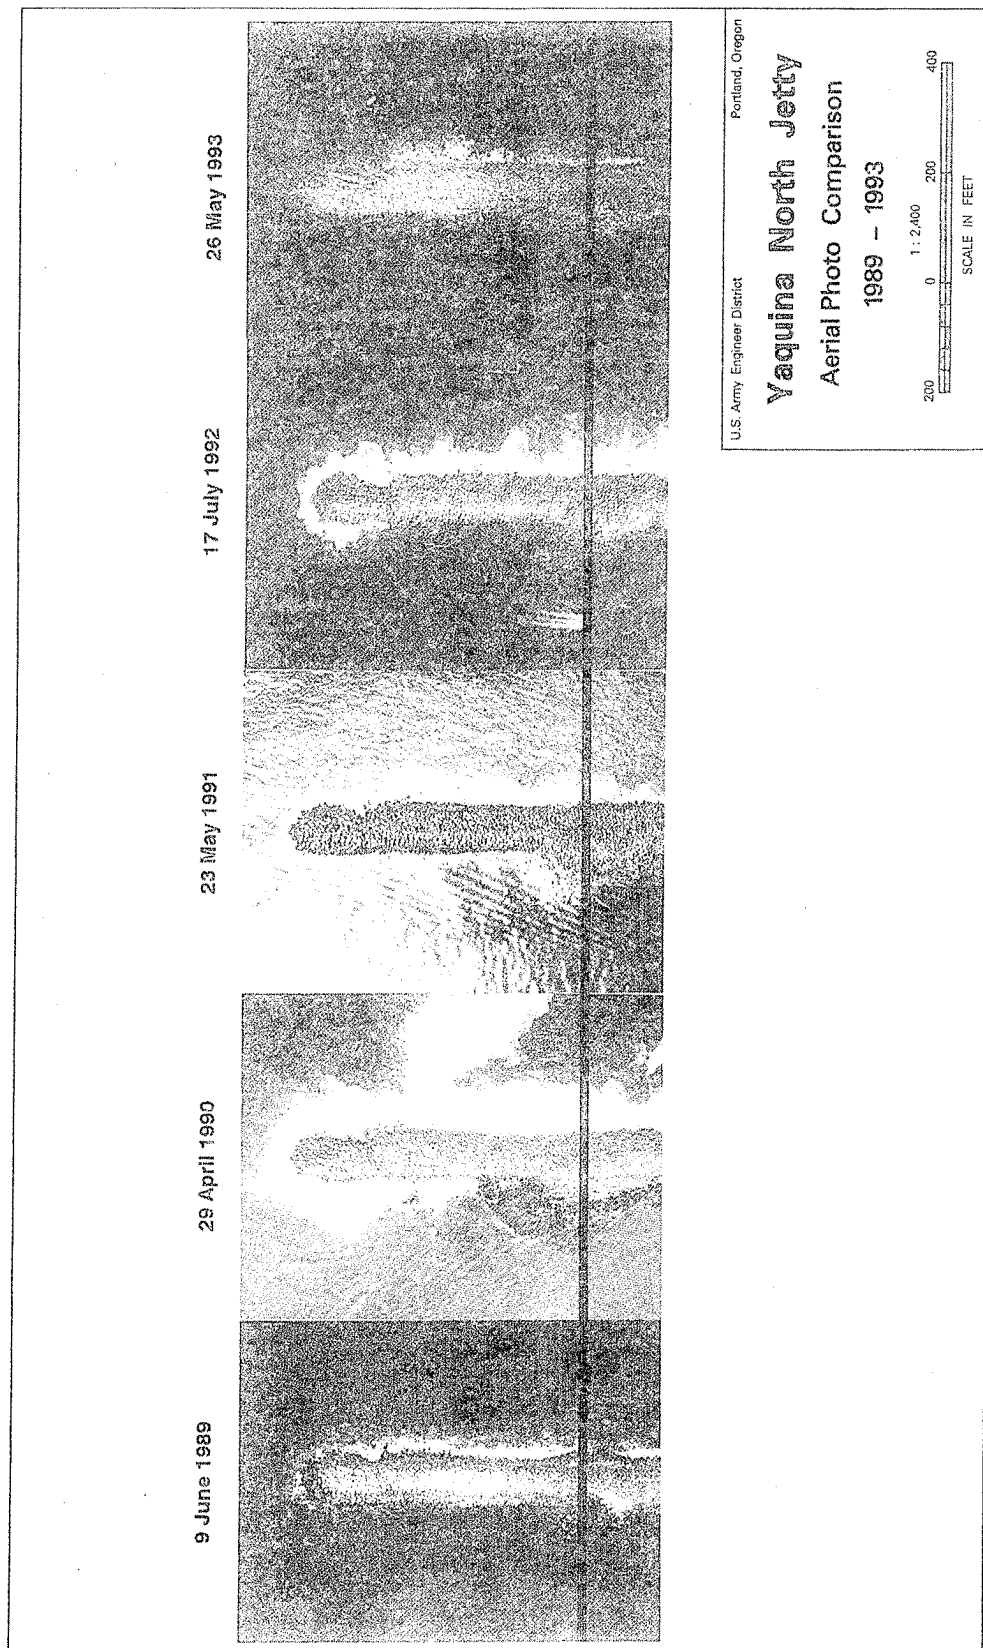
Figure 2. Yaquina Bay north jetty aerial photographs, 1989-1993

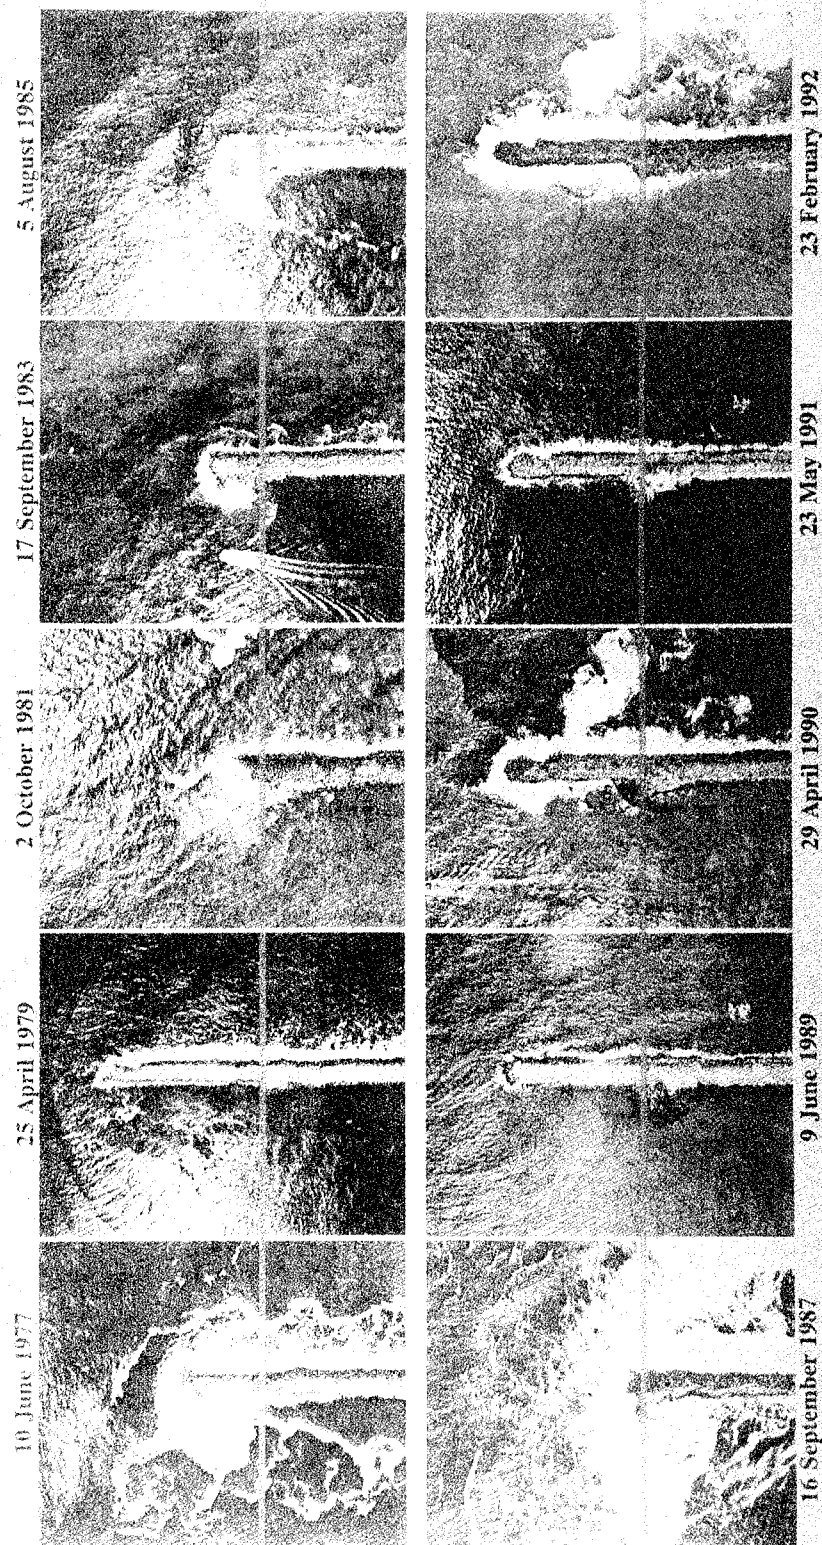
Almost immediately after completion of the north jetty rehabilitation, damage started to occur on the seaward tip of the structure. Aerial photographs indicated that 12 m (39 ft) of the tip was submerged by April 1979, with subsequent total submerged lengths of 68 m (224 ft) by October 1981, 115 m (379 ft) by September 1983, 124 m (406 ft) by August 1985, and 137 m (450 ft) by September 1987. This sequence of deterioration is shown by the aerial photographs in Figure 6 (the solid horizontal line on the figure is a common line of reference).

Figure 6. Yaquina Bay north jetty history from aerial photographs, 1977-1992

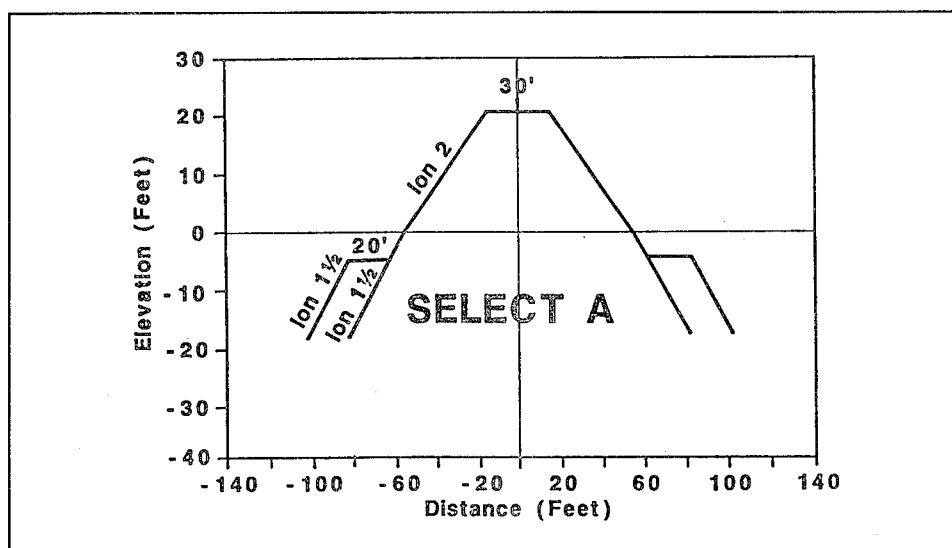
Figure 7 shows the nominal design cross section for rehabilitation of the seawardmost 30 m (100 ft) of the north jetty. The key differences of this design from the 1978 repair were elimination of the class "A" stone core and an increase in the size of the select class "A" armor stone. Thus, the entire end cross section of the jetty was constructed of select class "A" stone having an average weight of 29.5 tonnes (32.5 tons) with a minimum weight specified as 26.9 tonnes (29.7 tons). In addition, a 6-m-wide (20-ft-wide) bench was now included on both sides of the jetty. Behind the select class "A" stone repair section, the next 30-m (100-ft) repair length was armored using class "A" stone with an average weight of 23.4 tonnes (25.8 tons) (minimum 18.7 tonnes (20.6 tons)). The landwardmost portion of the rehabilitation was performed using class "B" stone having an average weight of 16.3 tonnes (18.0 tons) (minimum 12.2 tonnes (13.5 tons)). Details of the 1988 rehabilitation plan are shown on Figure 8. (Note that jetty stations given on Figure 8 do not correspond to jetty stations as labeled for this monitoring study.)

Figure 7. Yaquina Bay north jetty cross section, 1988 rehabilitation

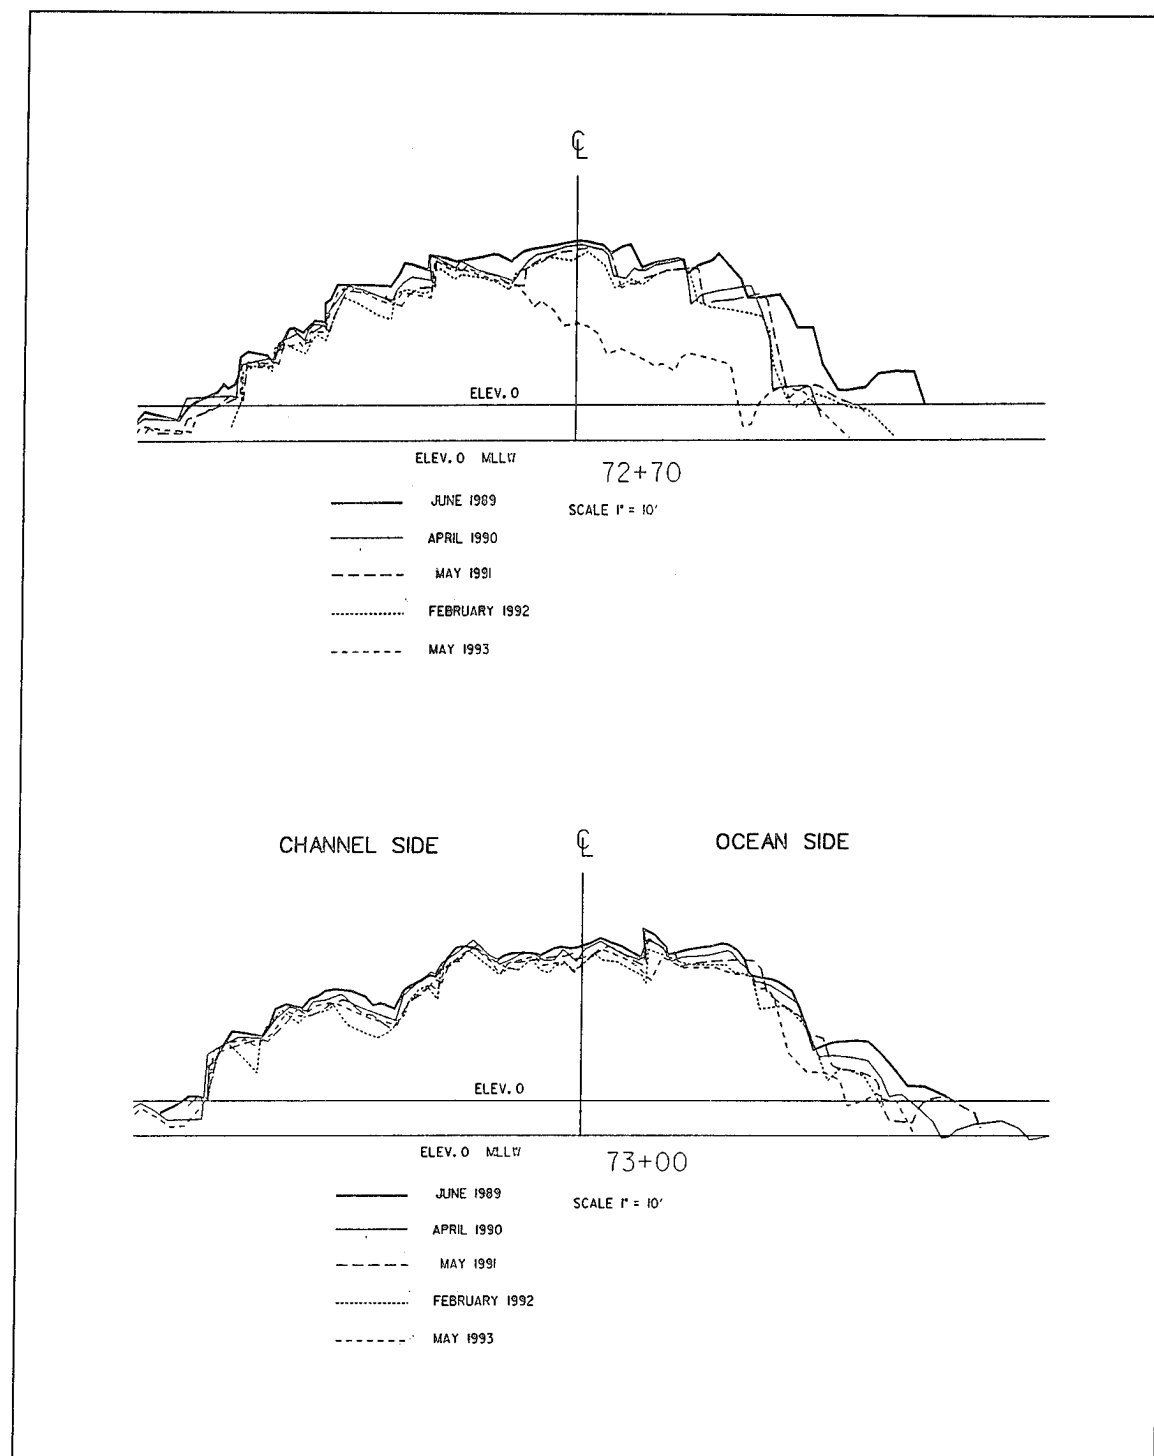
- c. The most profile change occurred in the vicinity of the "notch" (Figure 45, range 72+40). Significant damage occurred between the years 1989 - 1991. This was followed by a year when the only armor stone losses in the notch area occurred on the landward side of the notch. However, between the 1992 and 1993 overflights, massive profile losses occurred in the notch area to the extent that stones were lost over much of the structure's crest (see range 72+70, Figure 46).

Figure 46. Stereo-model jetty profile comparisons, ranges 72 + 70 and 73 + 00

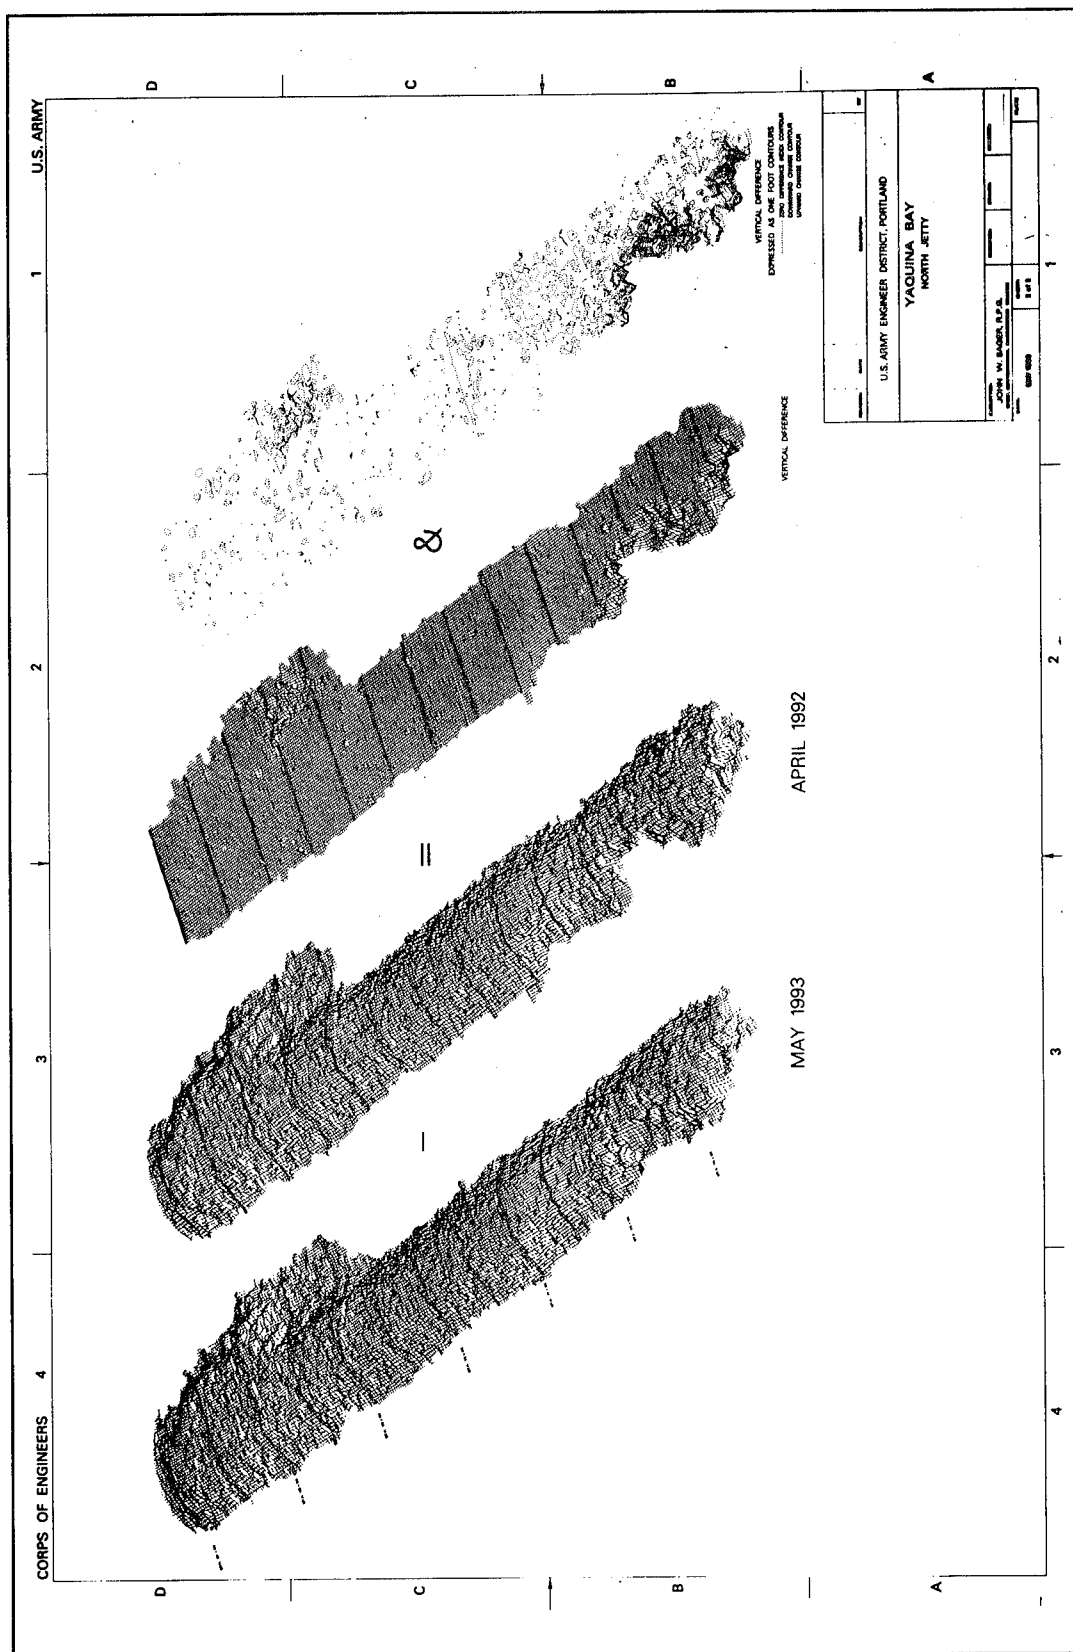
Figure 53. Yaquina Bay north jetty stone loss between 1992 and 1993

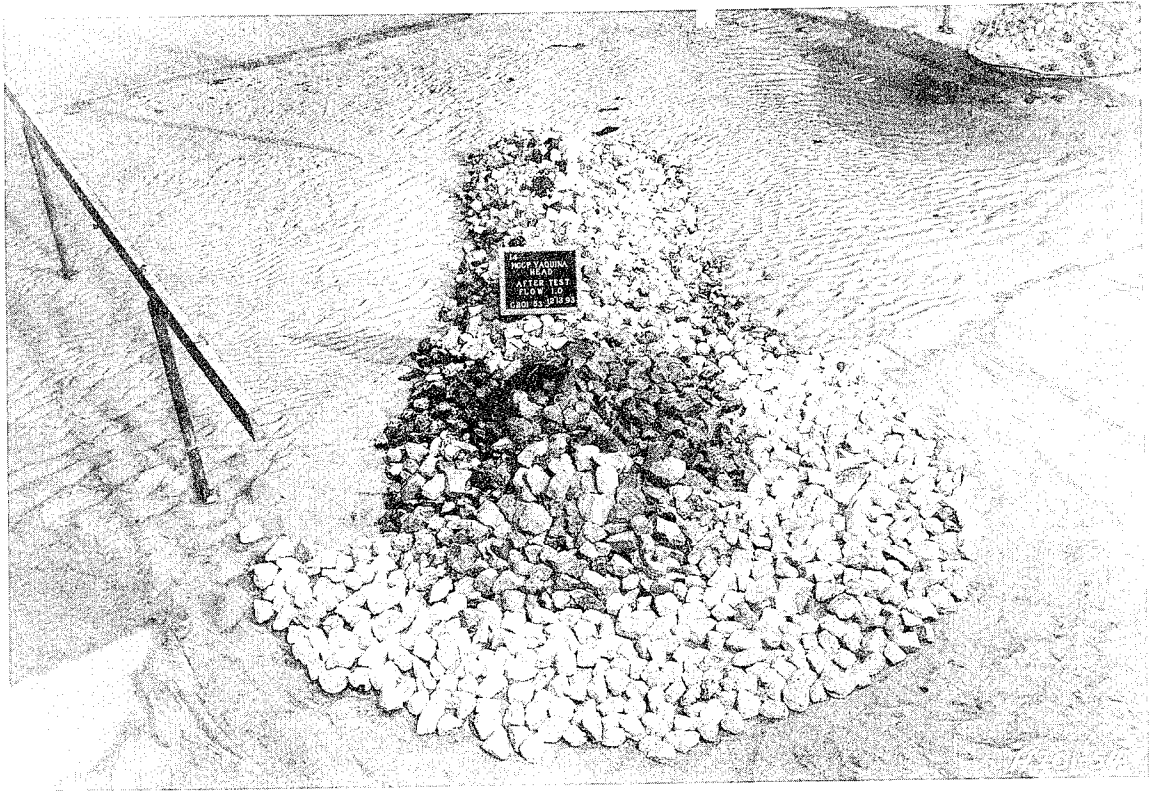
Figure 66. Wave/current stability model showing damage after Test 6
